Management of Overland Flow in CT Systems in the Northern Agricultural Region, W.A.

Peter Whale, Lyle Mildenhall and Paul Blackwell. Department of Agriculture and Food Western Australia, Three Springs and Geraldton Offices.

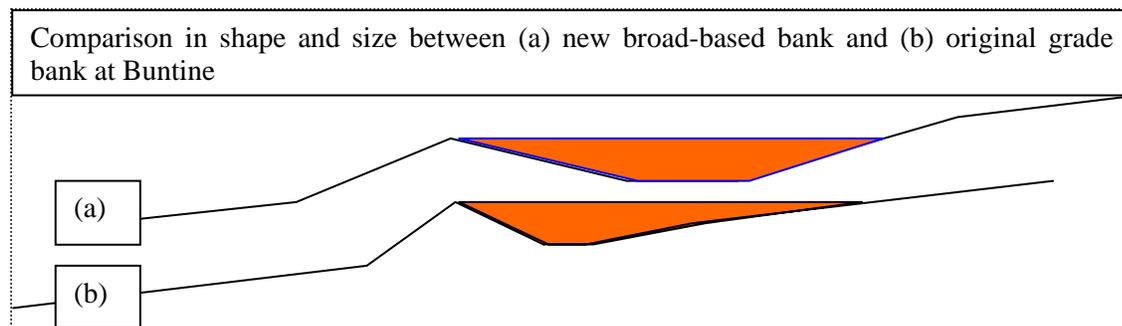
Using design criteria originally developed in Queensland – the first trial at Buntine involved the modification of an existing grade bank to form a broad-based bank, and the second at Pindar was a new structure. The broad-based bank has a channel increased to between 4-5m compared to a conventional grade bank with a channel width of 1-2m. The bank construction straddles about 20 to 25m but now the whole bank area can be sown to crop. The bank was traversed by air-seeder in the planting operation with ease, but operation of a spray rig was more difficult and slower.
